**Flood Control Project Maintenance  
Levee Inspections**

**2015 Channel Summary Report**

## San Joaquin County Flood Control and Water Conservation District

### Duck Creek Diversion Channel

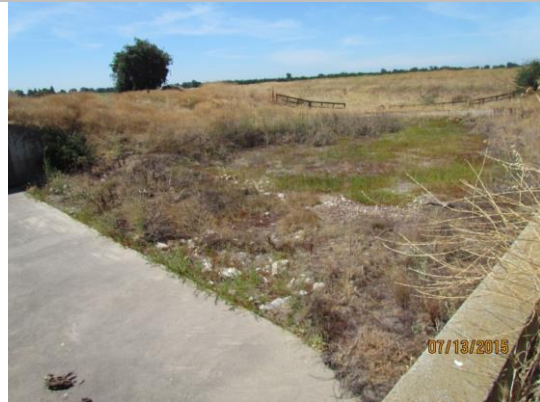
Photo 1 of 2 : CH\_2015\_NA0017\_43\_31\_20150817\_00014.jpg

Inspector Comments: Minimal vegetation in the channel should not impede the flow.

View of the vegetation in the diversion channel looking downstream during 2015 inspection.

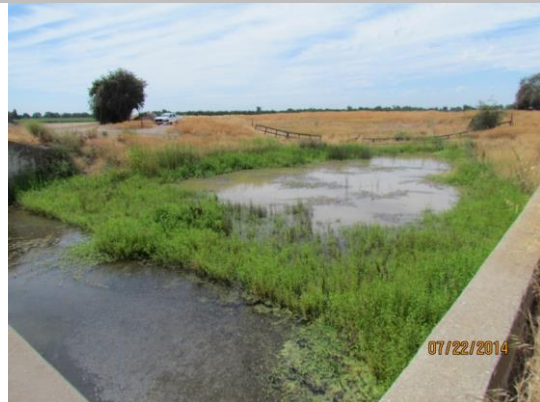
Photo 2 of 2 : CH\_2015\_NA0017\_43\_31\_20150710\_00012.jpg

View of the vegetation in the diversion channel looking downstream during 2014 inspection.

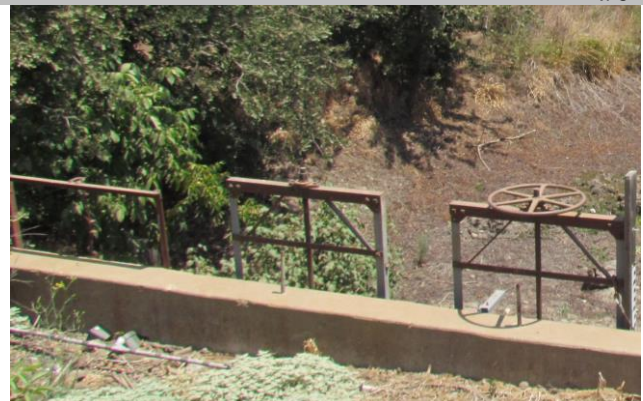
Photo 1 of 1 : CH\_2015\_NA0017\_42\_113\_20150818\_00046.jpg

Inspector Comments: Slide gates appeared to be in good operational condition, but gate wheels were missing from the gate.

View of the slide gate looking upstream of the channel.

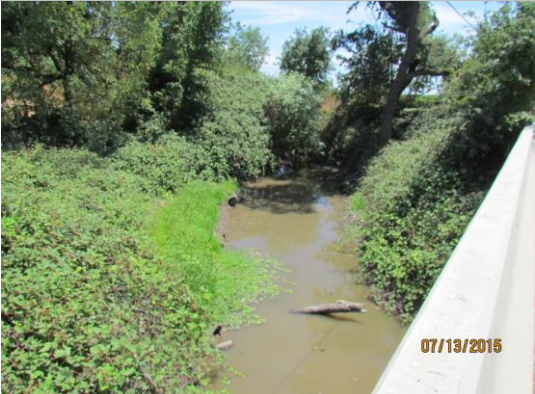
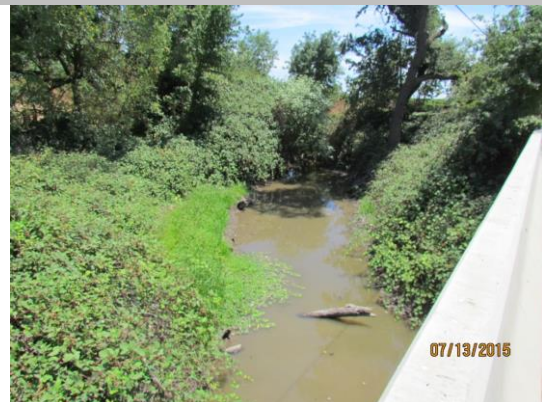
Photo 1 of 1 : CH\_2015\_NA0017\_42\_21\_20150818\_00048.jpg

Check Point / View				
Van Allen Rd / Up				
Rating **	M	Issue No.	21	GPS Lat/Long
Issue Type +	Ma	Location *		37.918960 °
Category	Rivers, Channels & Designated Flood			-121.056260 °
Item	Vegetation & Obstructions			
DWR ID	DWR_NA0017_42_c _ 2012_21			
Action/Comments				
Inspector Comments: Tree branches on the channel may cause an obstruction in the flow.

View of the vegetation looking upstream of the channel.

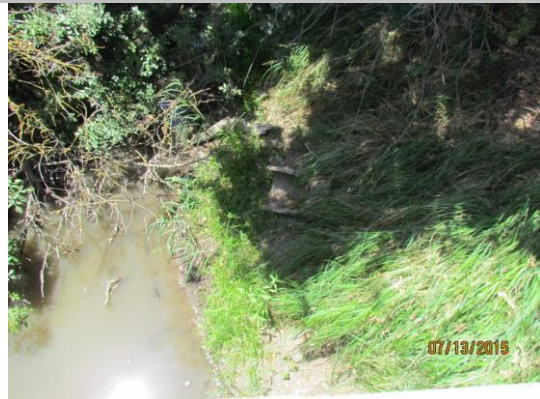
Photo 1 of 1 : CH\_2015\_NA0017\_42\_30\_20150818\_00050.jpg

Rating **	A	Issue No.	30	GPS Lat/Long
Issue Type +	Ma	Location *		37.918960 °
Category	Rivers, Channels & Designated Flood			-121.056260 °
Item	Encroachments			
DWR ID	DWR_NA0017_42_c _ 2012_30			
Action/Comments				
Inspector Comments: A broken pipe was found on the bank of the channel during inspection.

View of the broken pipe on the downstream of the channel.

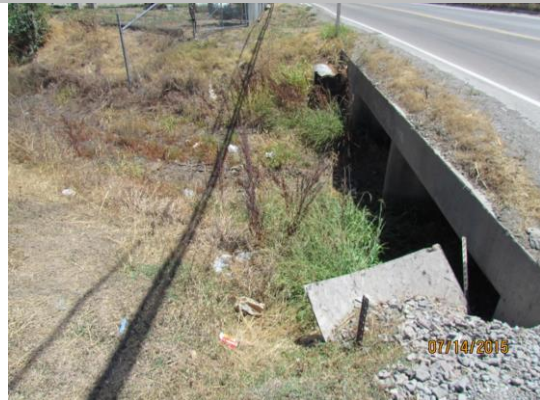
Photo 1 of 1 : CH\_2015\_NA0017\_42\_55\_20150818\_00058.jpg

View of the encroachments on the upstream of the channel.

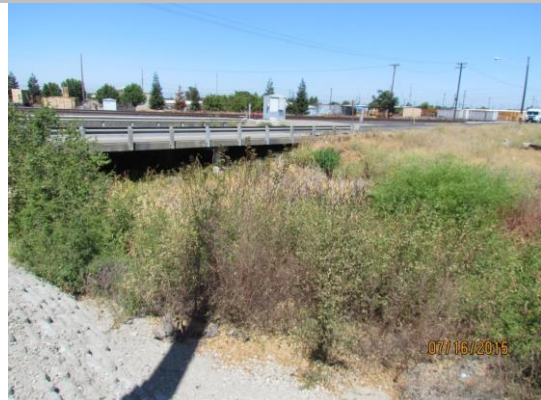
Photo 1 of 1 : CH\_2015\_NA0017\_42\_101\_20150819\_00068.jpg

View of the heavy vegetation on the channel looking upstream.

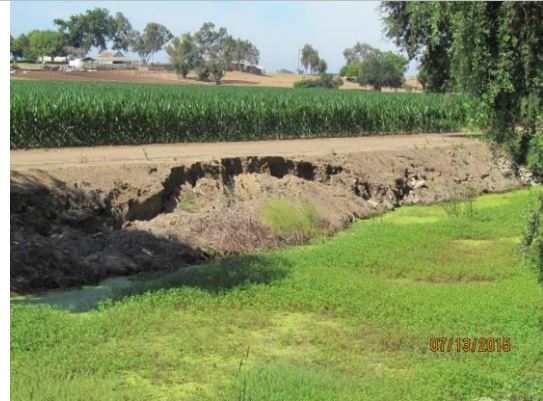
Photo 1 of 3 : CH\_2015\_NA0017\_44\_8\_20150817\_00053.jpg

View of the erosion on the left of the channel looking downstream during 2015 inspection.

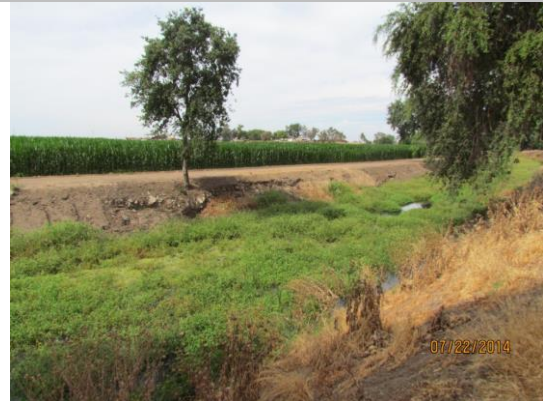
Photo 2 of 3 : CH\_2015\_NA0017\_44\_8\_20150710\_00003.jpg

Erosion was found on the channel bank looking downstream during 2014 inspection.

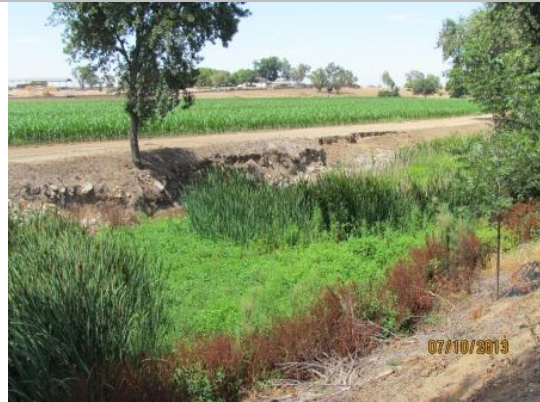
Photo 3 of 3 : CH\_2015\_NA0017\_44\_8\_20150710\_00004.jpg

Erosion was found on the channel banks looking downstream during 2013 inspection.

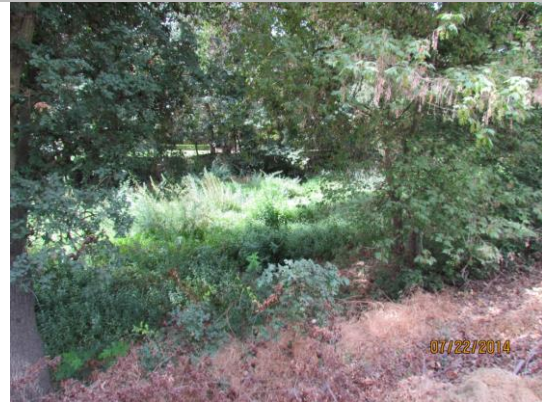
Photo 2 of 2 : CH\_2015\_NA0017\_44\_104\_20150710\_00042.jpg

Heavy vegetation was present on the downstream of the channel during 2014 inspection.

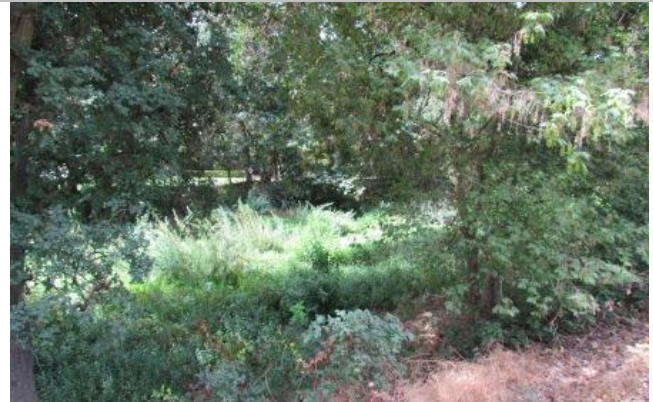
Photo 1 of 1 : CH\_2015\_NA0017\_44\_107\_20150820\_00091.jpg

View of obstructions on the channel looking upstream.

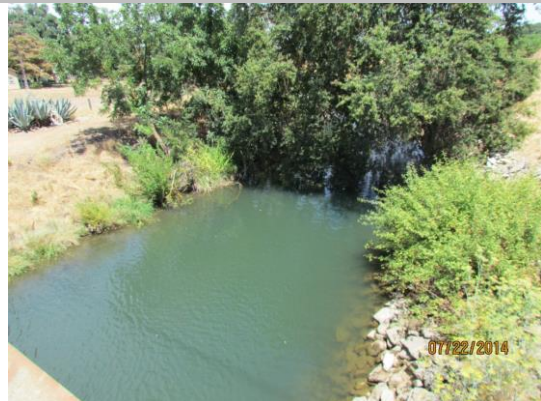
Photo 2 of 2 : CH\_2015\_NA0017\_44\_21\_20150710\_00007.jpg

Tree branches may cause obstruction on the channel. The picture was taken looking upstream during 2014 inspection.

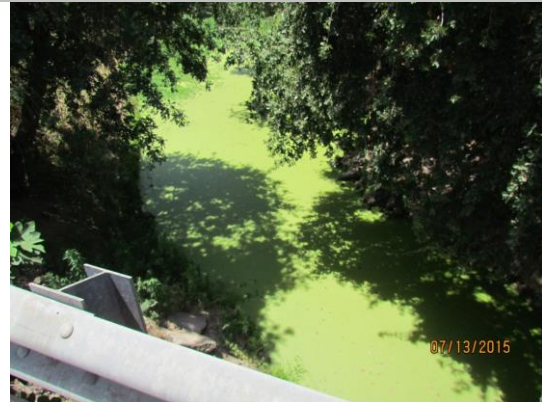
Photo 1 of 1 : CH\_2015\_NA0017\_44\_36\_20150818\_00067.jpg

Tree branches might obstruct the flow of the channel looking downstream.

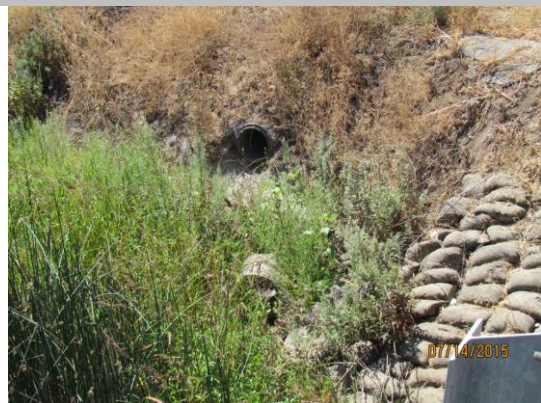
Photo 2 of 1 : CH\_2015\_NA0017\_44\_70\_20150818\_00079.jpg

View of a pipe with missing flap gate on the upstream of the channel.

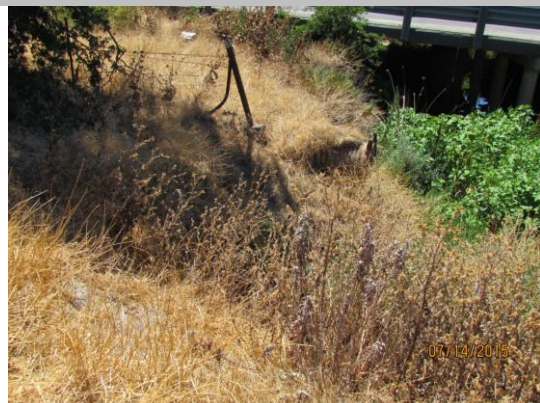
Photo 1 of 1 : CH\_2015\_NA0017\_44\_83\_20150818\_00084.jpg

View of the erosion on the channel bank looking upstream.

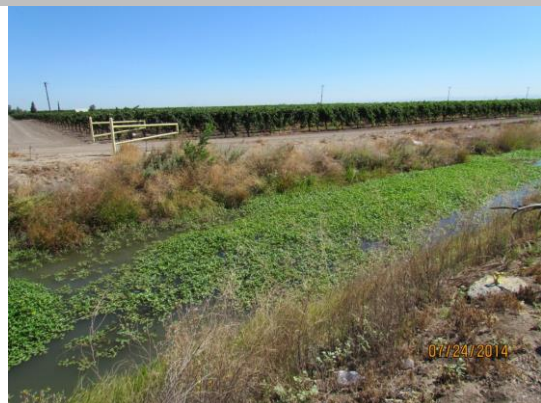
Photo 1 of 1 : CH\_2015\_NA0017\_45\_23\_20150710\_00008.jpg

View of the erosion on the channel bank looking upstream.
